Safety Management System Performance Measurement Report

October 2024

The report provides information regarding the performance of Endeavour Energy's Electricity Network Safety Management Systems (ENSMS) which has been prepared in accordance with the Electricity Supply (Safety and Network Management) Regulation 2014 (ESSNM). It comprises two sections:

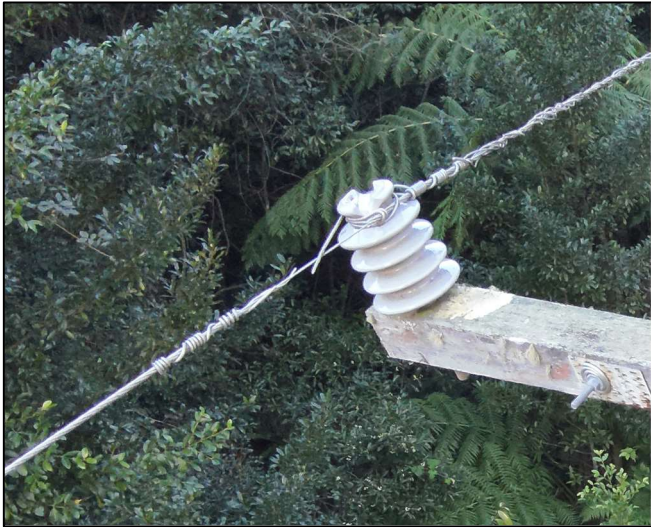
Figure 3 - Drone image

The drones captured close-up imagery that identified defects not easily identifiable from the helicopter images.

“These innovative drones boast autonomous flying capabilities, enabling them to navigate pre-programmed routes while avoiding obstacles under the vigilant monitoring and control of a licensed drone operator. They capture precise images of electrical assets, even in hard-to-reach locations. This transition aligns with Endeavour Energy’s commitment to evolving and improving network management to ensure customer safety, reliable electricity supply, and affordability”.

The use of Drones this year enabled efficient capture with enhanced images identifying more defects while reducing CO₂ emissions by 75%. The program was a success and will be continued in future years.
